# Field test „F16“

## 1. The frame

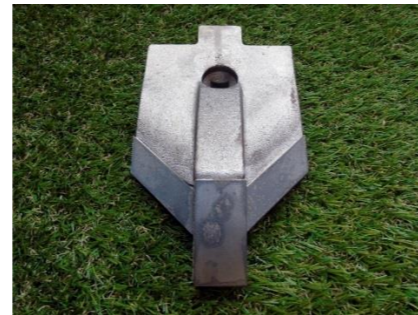
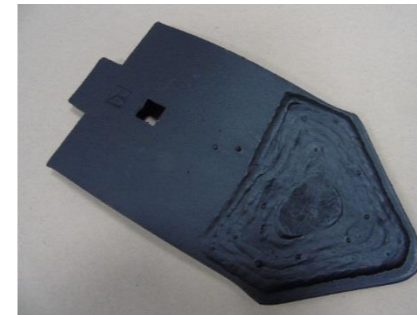
Both of our points in original condition – our “F16” here left. We will get to the wear of standard point later.

The start of the test was in the summer of 2016 right before the stubble processing began. We then dismantled the relevant points in several phases to weigh and document the different states during their use. The following pictures should give you an overview about the abrasive wear. To have a comparison, we

also mounted a “standard” point with reinforcements welded underneath.

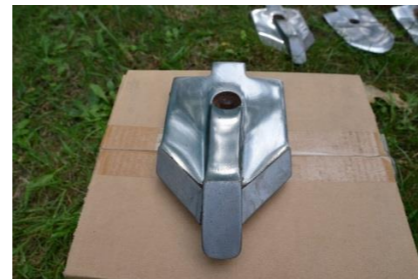
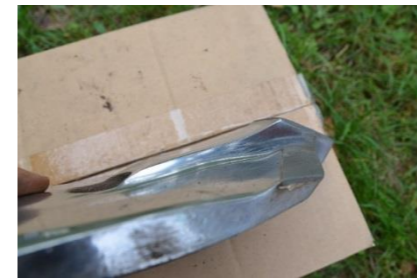
After about 255 hectares, the first abrasion was clearly visible. The edges of the front tip were already ground and there were slight extractions on top of the point. The loss of weight was about 420 g which was nearly 13% of the total mass.

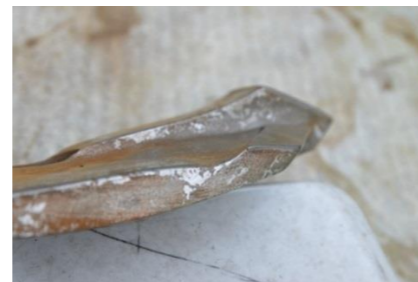
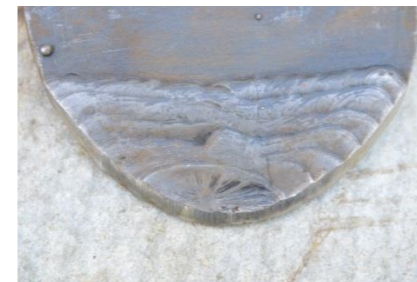
At the end of the year, the points had worked an area of about 360 hectares. While the „F16“ showed almost no further abrasion, the „standard tip was worn out to the half way point of the reinforcement. The loss of weight of the “F16” was about 510 g which was nearly 16.3% of the total mass. The “standard” point had lost around 950 g. That is almost 43% of its total mass. We decided not to use this point any further, because it had some beginning cracks which would have caused it to break soon after.

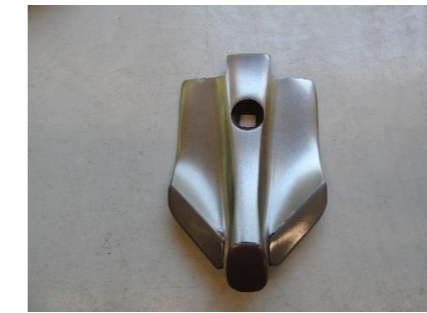
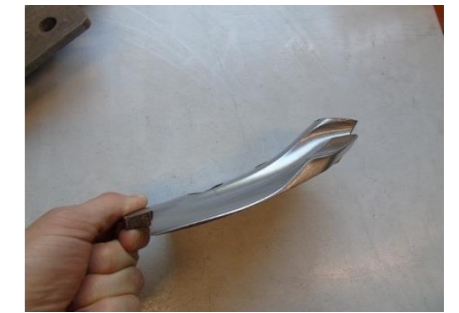
In 2017, we continued the test with the „F16“ until it reached its current condition. It would have been able to achieve more ground coverage, but the possible loss of the point without notice would have made it impossible to evaluate the test completely. We decided to keep it in this state as an example to conduct an examination.

After the evaluation of the test, we came to a total ground coverage of around 1186 hectares. *Of course, this is not a general value.* It depends on soil condition, working depth and speed. But it clearly shows in which direction the further development is going.
